DEPARTMENT OF TRANSPORTATION**DIVISION OF ENGINEERING SERVICES**

Quality Assurance and Source Inspection

Contract #: 04-0120F4Cty: SF/ALA Rte: 80 PM: 13.2/13.9File #: 69.28**WELDING INSPECTION REPORT****Resident Engineer:**Pursell, Gary**Address:** 333 Burma Road**City:** Oakland, CA 94607**Report No:** WIR-002083**Date Inspected:** 26-Mar-2008**Project Name:** SAS Superstructure**OSM Arrival Time:** 1730**Prime Contractor:** American Bridge/Fluor Enterprises, a JV**OSM Departure Time:** 800**Contractor:** Zhenhua Port Machinery Company, Ltd (ZPMC), Changxing Island **Location:** Shanghai, China**CWI Name:** See Below**CWI Present:** Yes No**Inspected CWI report:** Yes No N/A**Rod Oven in Use:** Yes No N/A**Electrode to specification:** Yes No N/A**Weld Procedures Followed:** Yes No N/A**Qualified Welders:** Yes No N/A**Verified Joint Fit-up:** Yes No N/A**Approved Drawings:** Yes No N/A**Approved WPS:** Yes No N/A**Delayed / Cancelled:** Yes No N/A**Bridge No:** 34-0006**Component:** OBG and Tower**Summary of Items Observed:**

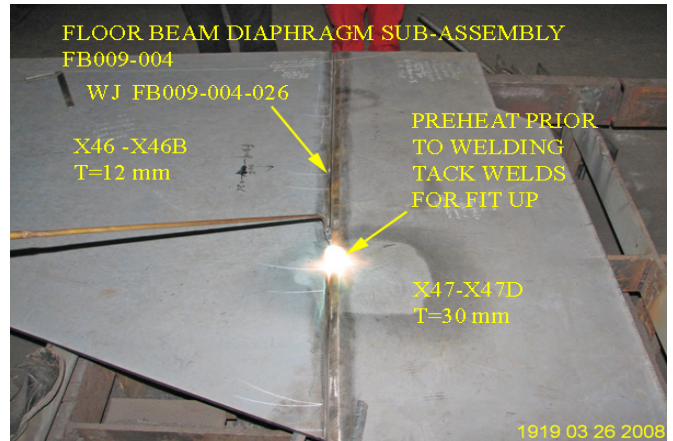
The QA Inspector randomly observed ZPMC Welder Yang Xuhe ID Number 057795, utilizing the Shielded Metal Arc Welding (SMAW) Process in the 1G (Flat Groove) Position with ZPMC WPS WPS-B-P-2211-B-U2-FCM, to tack weld Floor Beam FB014-02 Diaphragm Flange (T=30 mm to T=12 mm) sections at WJ FB009-004-026. The QA Inspector randomly observed ZPMC CWI Huang Wen-Pang, monitoring weld parameters. Weld parameters appeared to comply with contract requirements. The attached photograph provides additional detail.

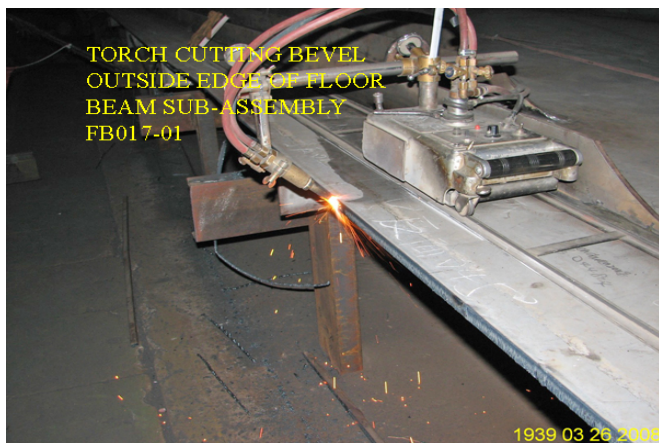
The QA Inspector randomly observed a ZPMC torch cutting operator utilizing a track mounted semiautomatic torch cutting apparatus, to cut the bevels in 30 mm/12mm thick abutting Floor Beam Diaphragm sections. The attached photograph provides additional detail.
